TECHNICAL SERVICE BULLETIN

Glove Compartment Door Difficult To Latch Or Misaligned

19-2341
15 November 2019

Ford 2015-2020 F-150

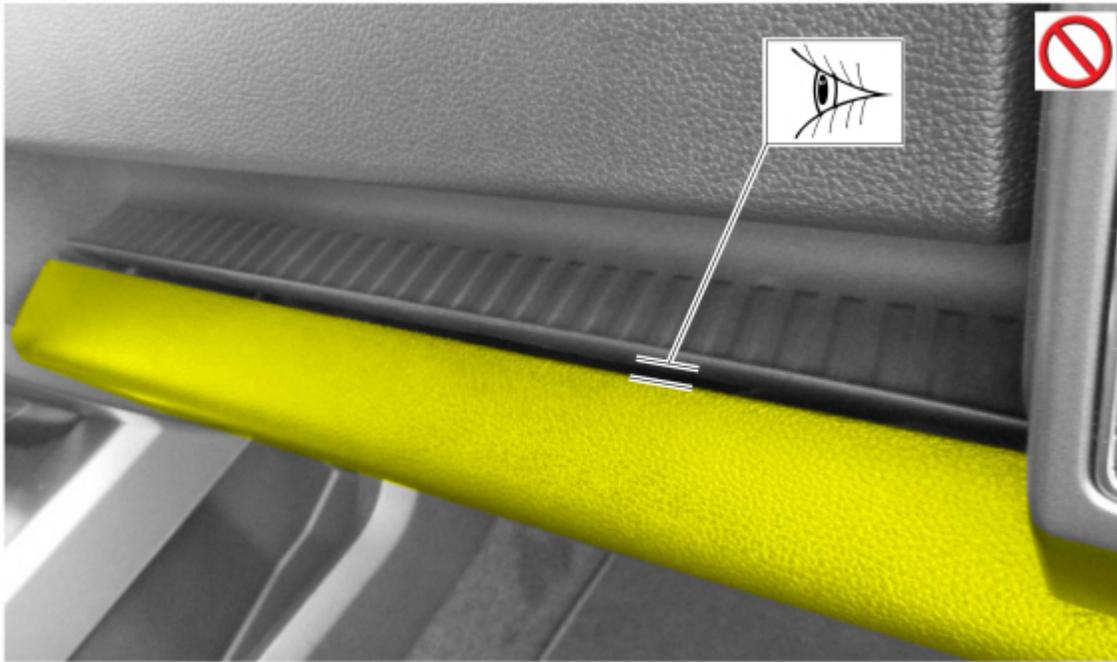
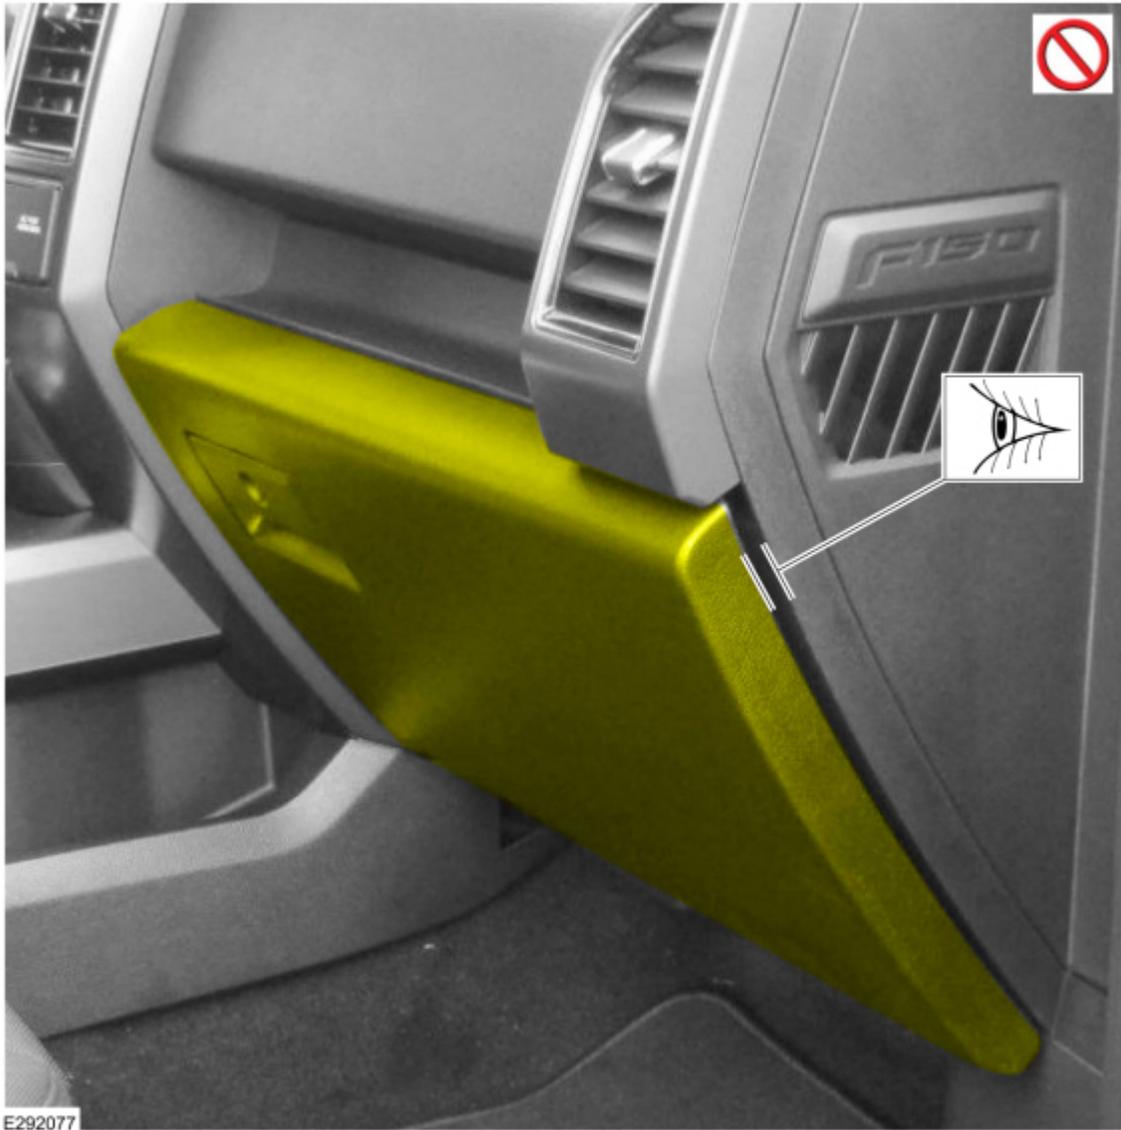
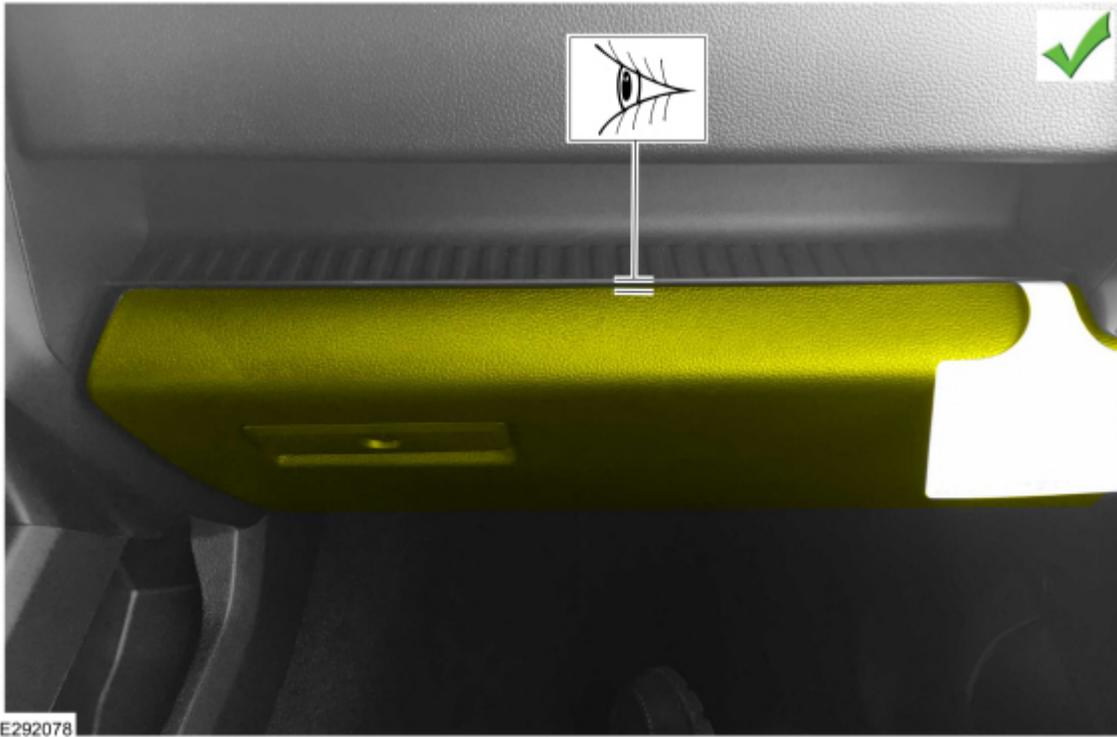
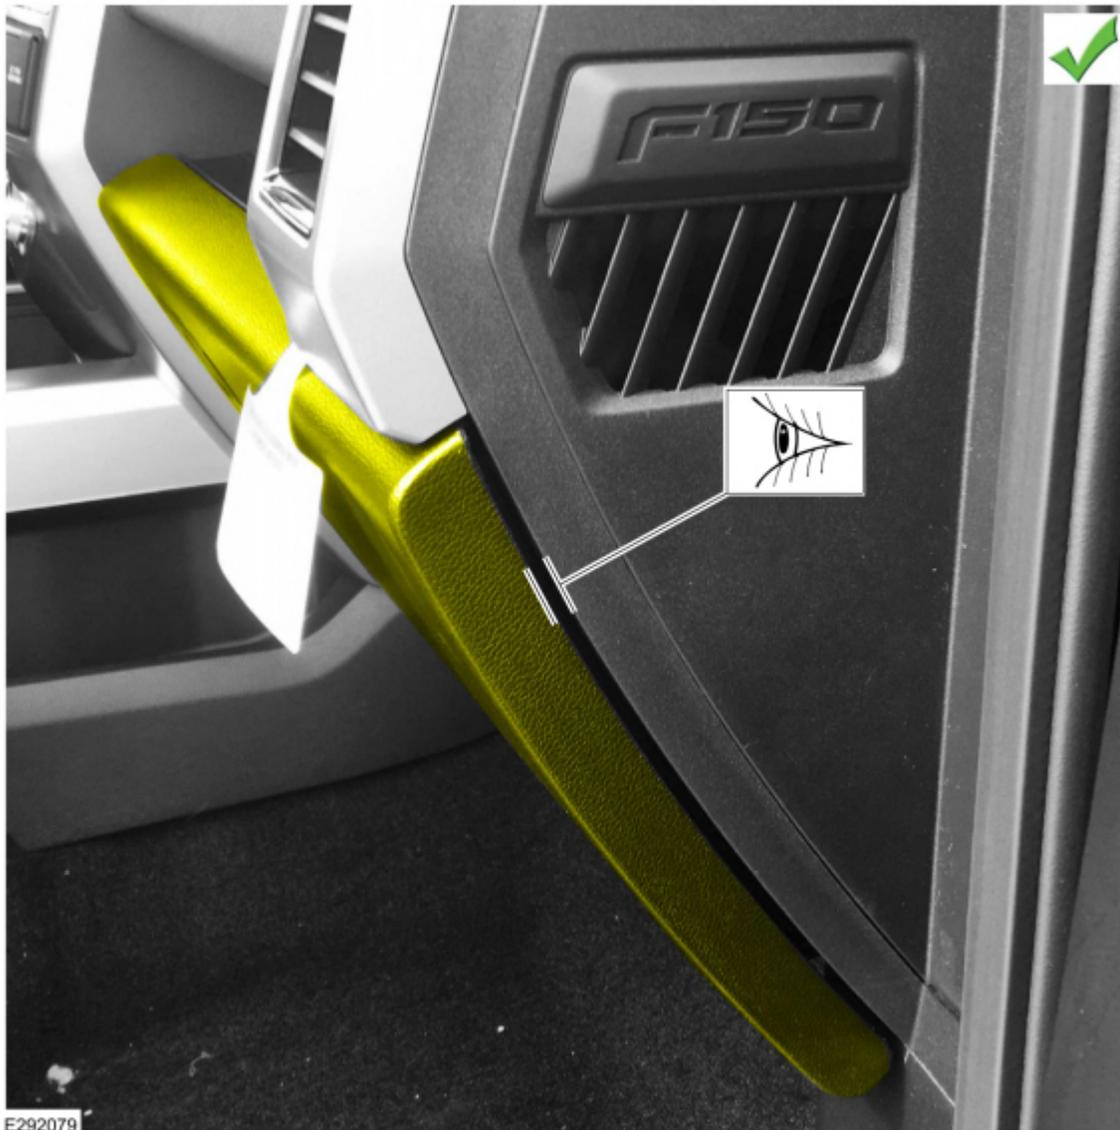
1. Open and close the glove compartment door and inspect the glove compartment door in the closed position. Is the glove compartment door difficult to latch on one or both sides or does it exhibit a misalignment at the storage tray and/or right side instrument panel with no other visible defect? (Figures 1-4)

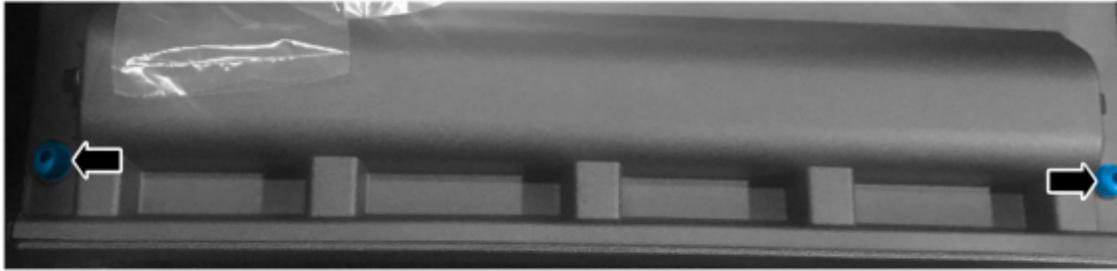
Figure 5

2. Remove the bumpers from the glove compartment door and close it. Does the glove compartment door latch properly? (Figure 5)

(1). Yes - if the glove compartment door closes properly with the bumpers removed, the bumpers have taken a set in the door open position giving the appearance the glove compartment is warped.

Bumpers that have become set in the open position increase closing force and inhibit proper latching.

- Install the bumpers and close the glove compartment door fully. Make sure both sides are latched. Increased closing force may be required to properly latch the glove compartment door. Inform the customer that it takes 2 to 24 hours for the bumpers to become set in the closed position depending on ambient temperature.

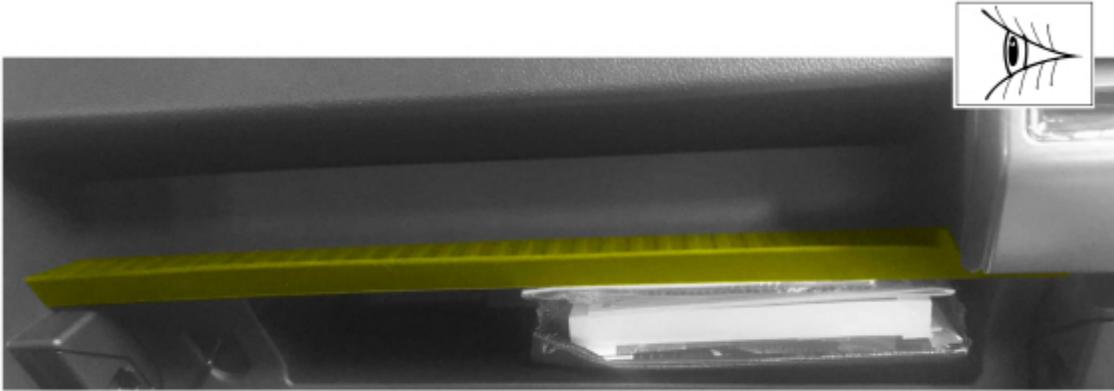
Figure 7

3. Inspect the glove compartment storage tray rubber mat. Is the mat properly seated and flush on both ends of the instrument panel? (Figures 6-7)

4. Remove the rubber mat and close the glove compartment door. Refer to WSM, Section 501-12. Does the glove compartment door close properly?
 - (1). Yes - the rubber mat was installed incorrectly. Install the rubber mat making sure the right side is properly tucked and seated to the instrument panel. Refer to WSM, Section 501-12. Proceed to Step 5.
 - (2). No - install the rubber mat and proceed to Step 5. Refer to WSM, Section 501-12.
5. Inspect the glove compartment door left and right hand strikers. Are the strikers fully seated? (Figures 8-10)
 - (1). Yes - proceed to Step 7.
 - (2). No - proceed to Step 6.

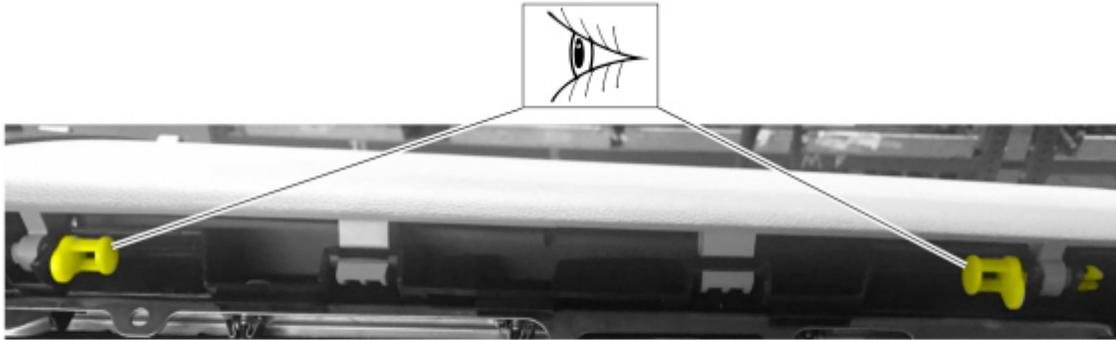
Figure 11

6. Remove the improperly installed striker using a non-marring pry tool and reinstall. Make sure the striker is fully seated.
7. Inspect the glove compartment door hinge pins. Are both pins fully seated? (Figure 11)
 - (1). Yes - proceed to Step 9.
 - (2). No - proceed to Step 8.

- 8.** Remove and reseal the hinge pins.
- 9.** Close the glove compartment door and inspect for proper alignment. Is the door properly aligned and latched on both sides?
 - (1). Yes - repair is complete.
 - (2). No - proceed to Step 10.
- 10.** Replace the glove compartment door. Refer to WSM, Section 501-12.
